# Debris/Ice/TPS Assessment and Integrated Photographic Analysis for Shuttle Mission STS-54

(NASA-TM-107558) DEBRIS/ICE/TPS  
ASSESSMENT AND INTEGRATED  
PHOTOGRAPHIC ANALYSIS FOR SHUTTLE  
MISSION STS-54 Final Report, 12-21  
Jan. 1993 (NASA) 146 p

DEBRIS/ICE/TPS ASSESSMENT  
AND  
PHOTOGRAPHIC ANALYSIS  
OF  
SHUTTLE MISSION STS-54

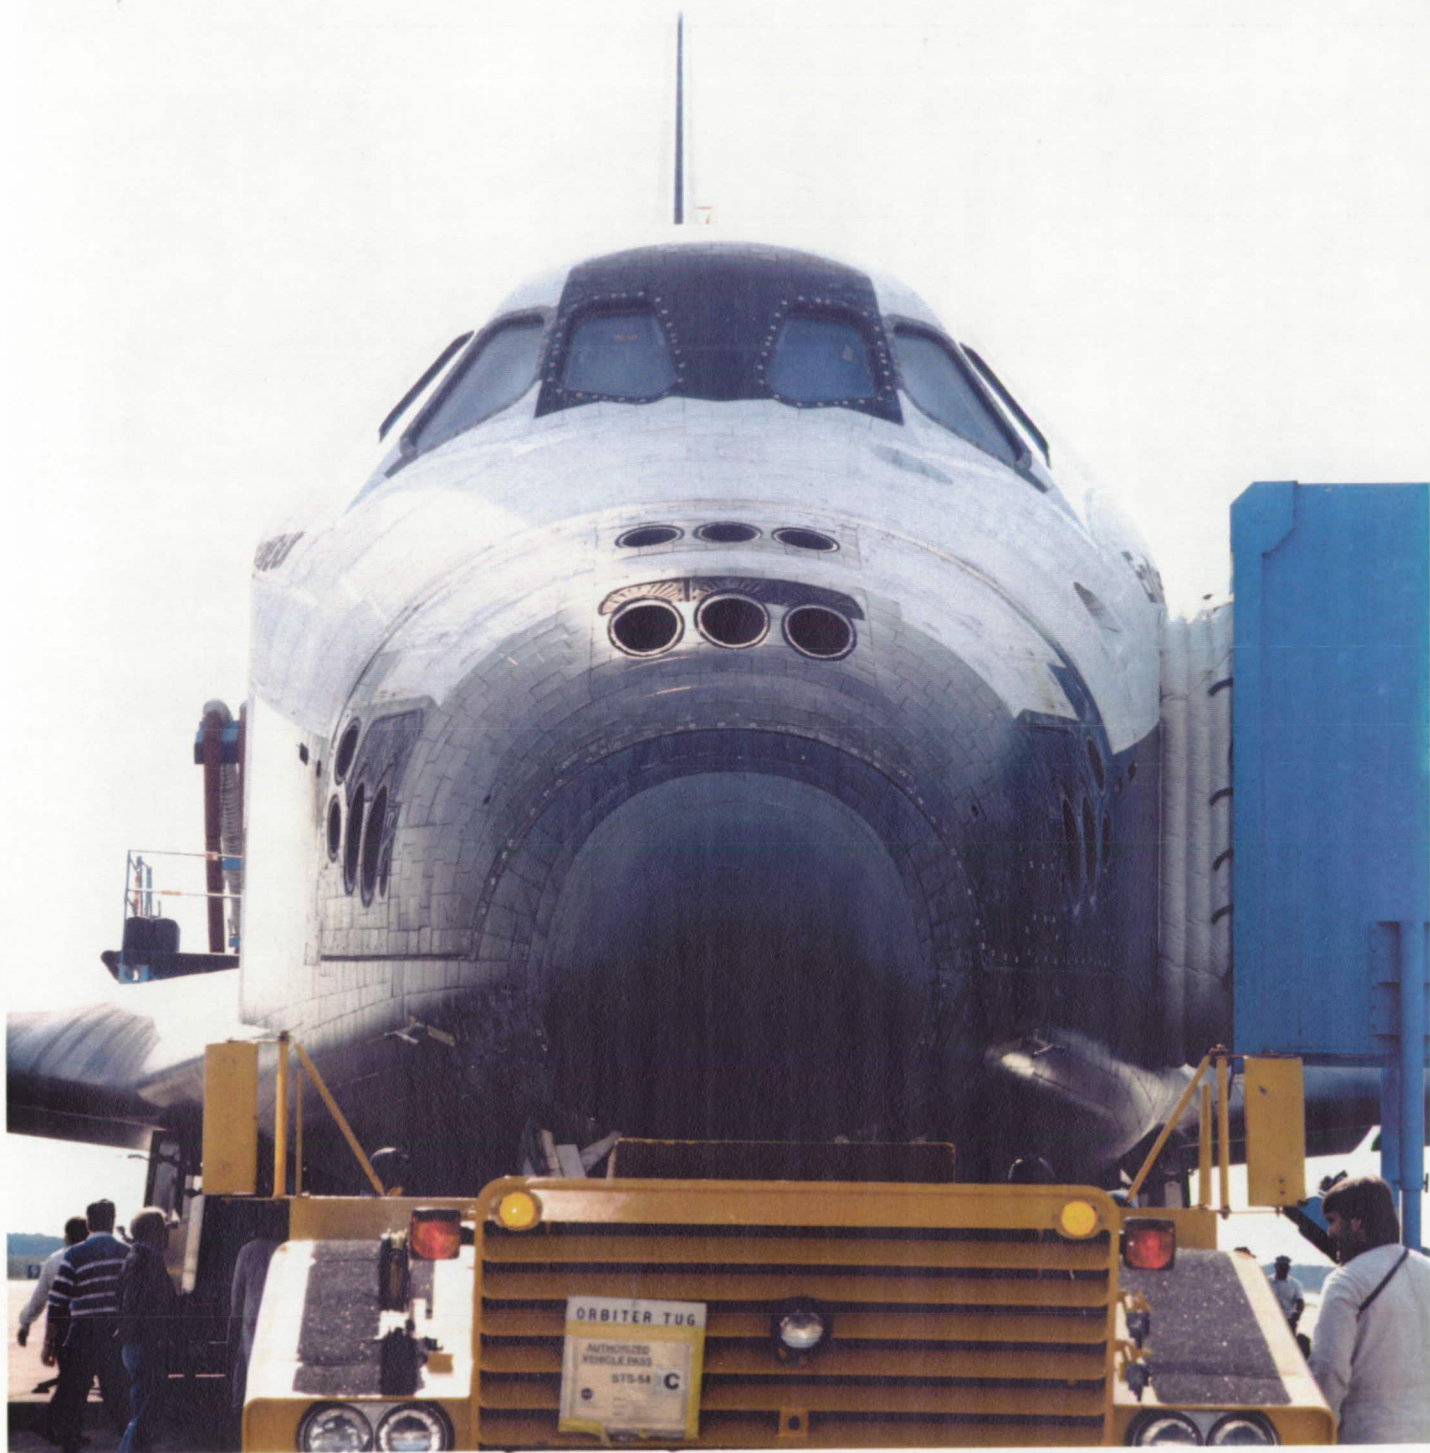
Orbiter windows #3 and #4 exhibited moderate hazing and several streaks. Only a very light haze was present on the other forward facing windows.

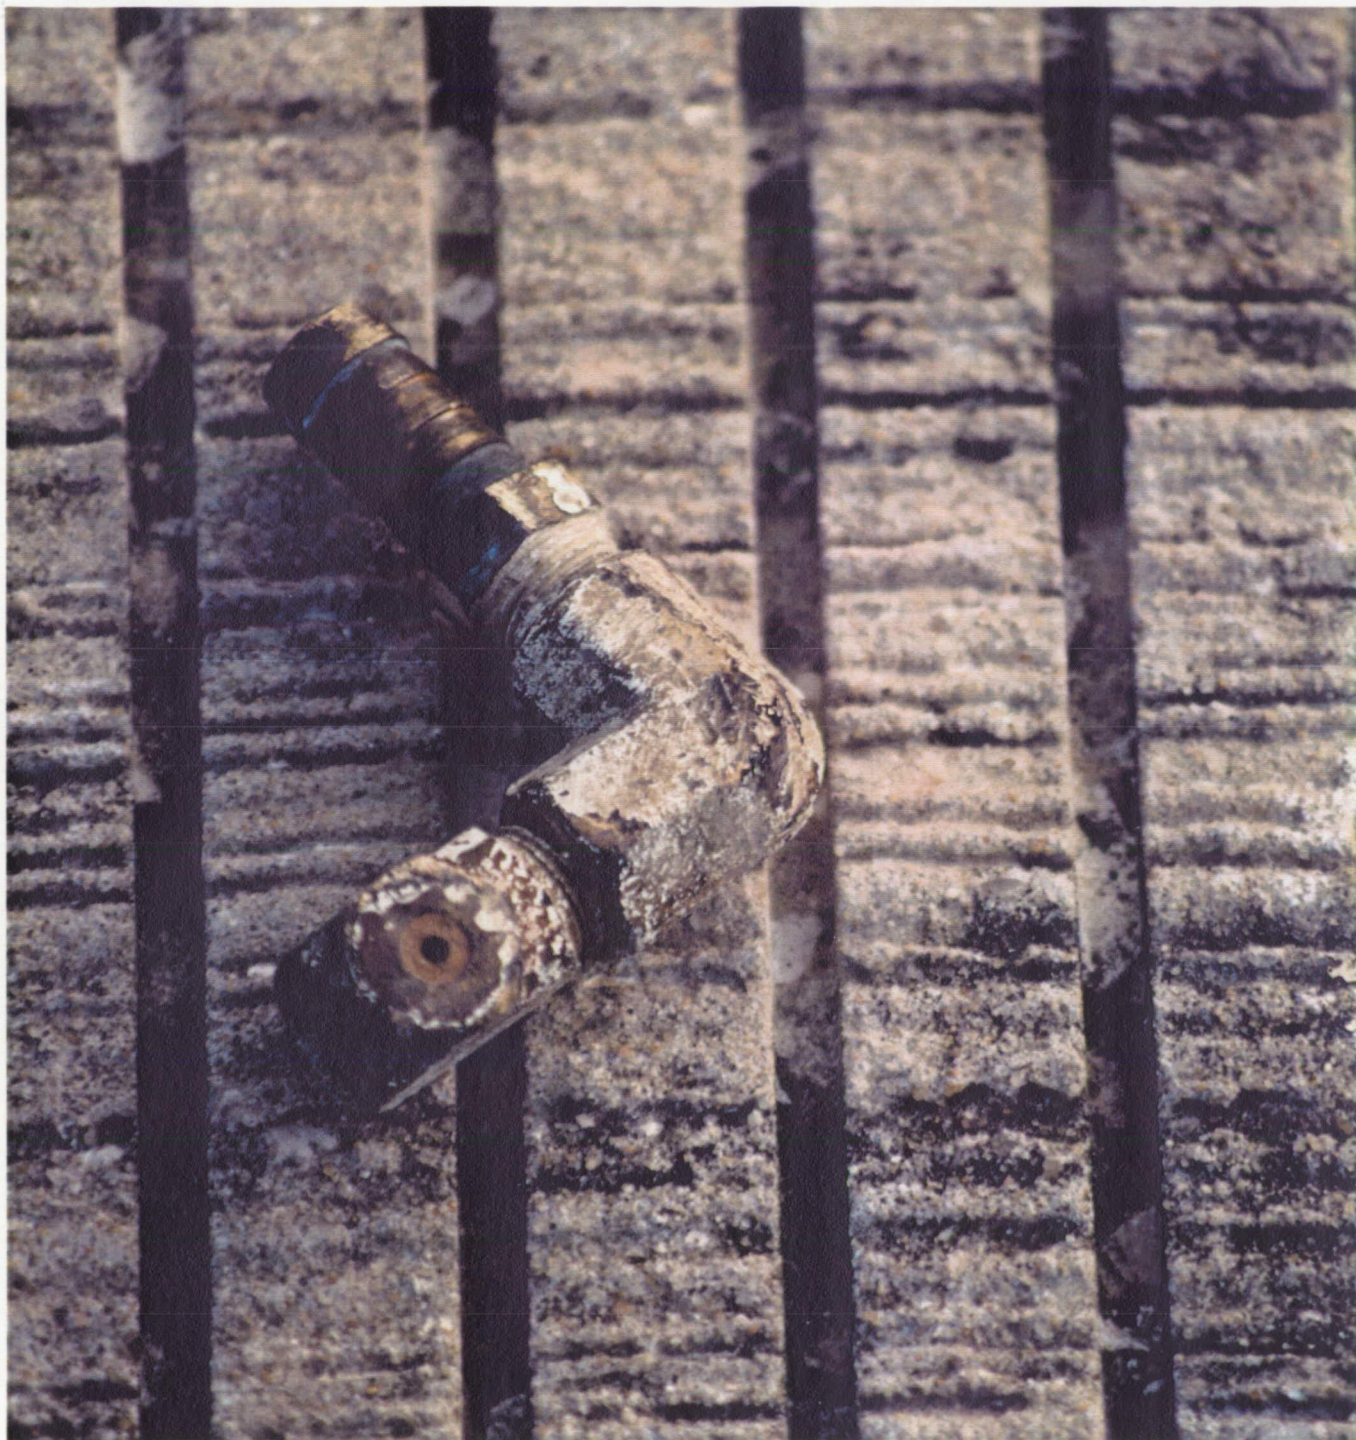
A post landing inspection of Runway 33 was performed immediately after landing. An 8 ounce, 2.5" x 2.25" x 0.5" thick, brass spray nozzle/elbow was found at the 3800 foot marker, 18 feet east of the runway centerline. This nozzle originated from the runway sweeper.

An 8 ounce, 2.5" x 2.25" x 0.5" thick, brass spray nozzle/elbow was found at the 3800 foot marker 18 feet east of the runway centerline. The nozzle originated from the runway sweeper.

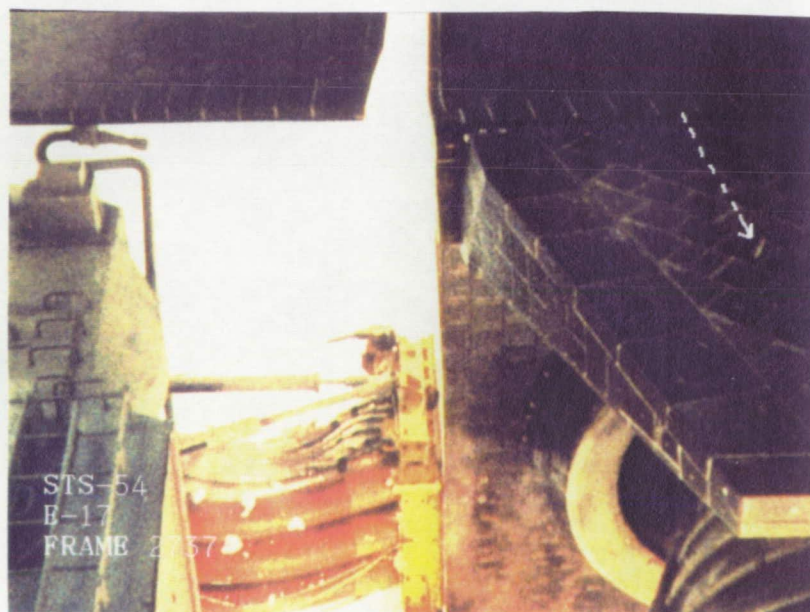
**Figure 2.1.1.2 Debris from Body Flap Hinge Gap**

A brown-colored object, 6 inches long by 1 inch wide, appeared in the body flap hinge area and fell aft during SSME ignition. The object is believed to be a brown GSE tile shim, or spacer.

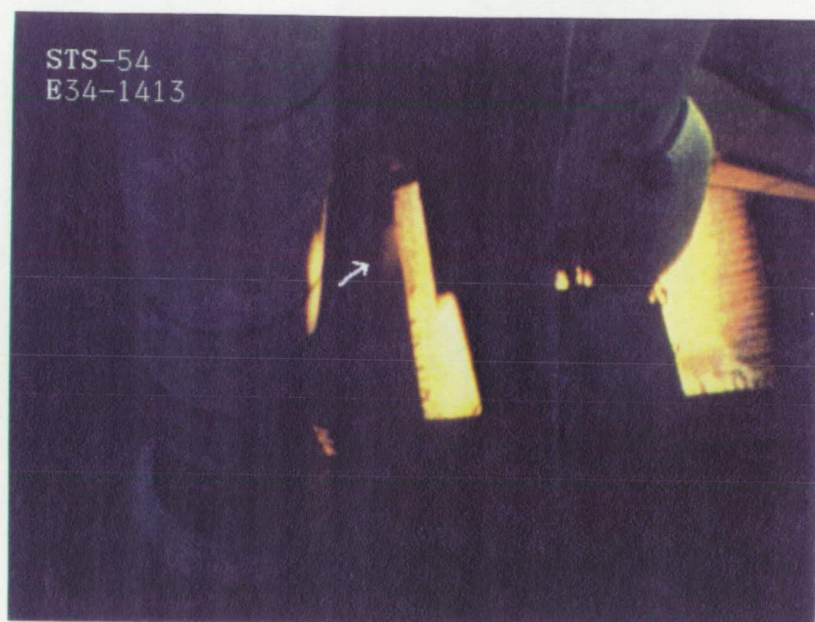
**Figure 2.2.2****Orange Vapor Curling under Body Flap**

On E-17, E-18, E-30, E-36, E-41 and OTV-163, an orange vapor (possibly free burning hydrogen) was seen curling under the body flap at T-5.37 seconds MET. An orange vapor was noted below the SSME bells on E-2 and E-3 prior to SSME ignition.

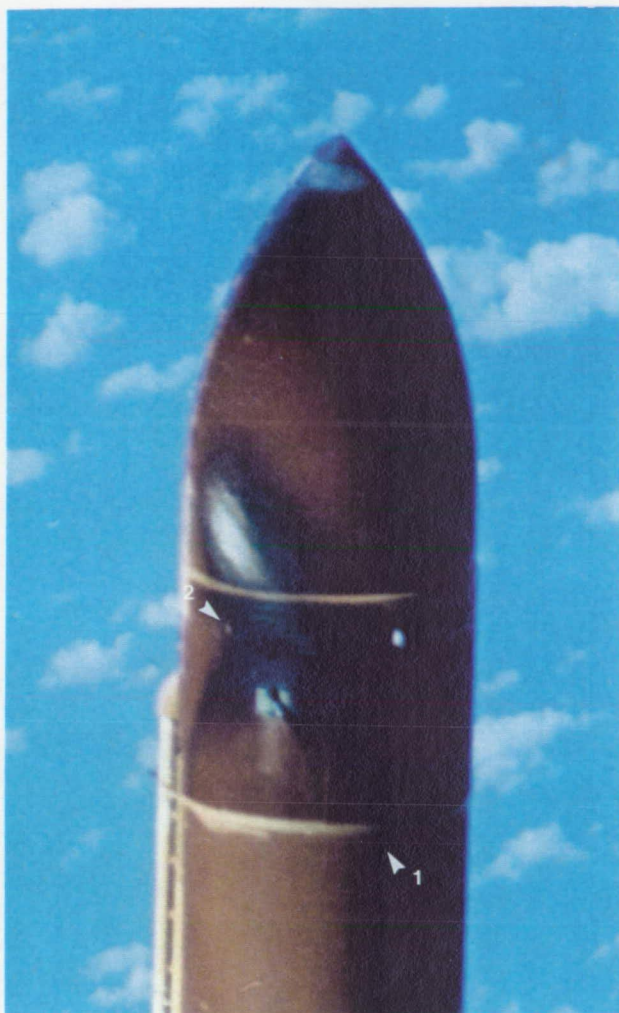
**Figure 2.4.1 (A)****Handheld Camera View of the Right Side (+Y Axis) of ET  
(Frame STS-54-27-024)**

Magazine 27 viewed the nose cone/O-Give and the right side (+Y axis) of the ET. From frame 13 through frame 24 a possible small divot was observed on the LH2 intertank interface (1). A second possible divot was noted in the intertank area below the right SRB burn separation motors (BSM) burn scar (2). The second divot could not be confirmed since a close-out photograph of this region was not available.

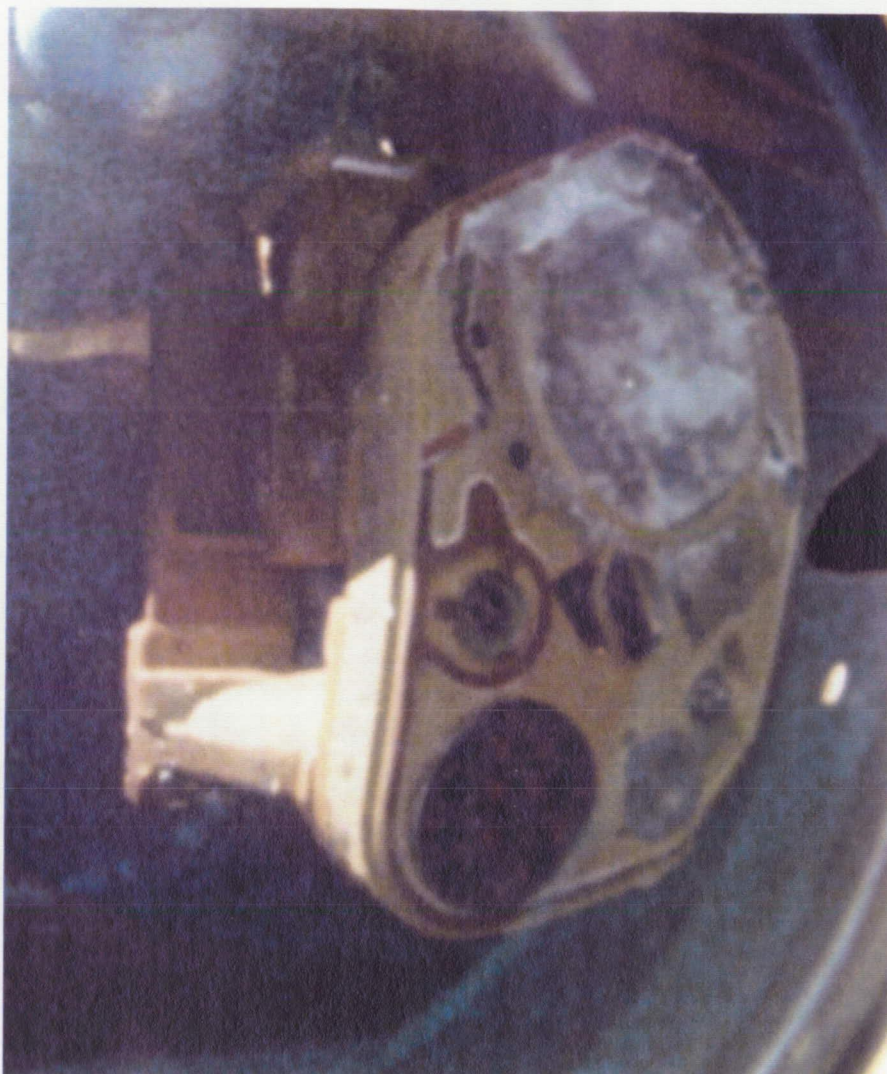
**Figure 2.4.2.2.2 (C) ET LH2 Umbilical after ET Separation**  
(Frame STS-54-57-5228)

Multiple pieces of white debris (possibly ice from the umbilical vent purge) were seen throughout the ET separation sequence. White debris was seen to strike the ET electrical cable tray and break into smaller pieces just prior to ET separation.

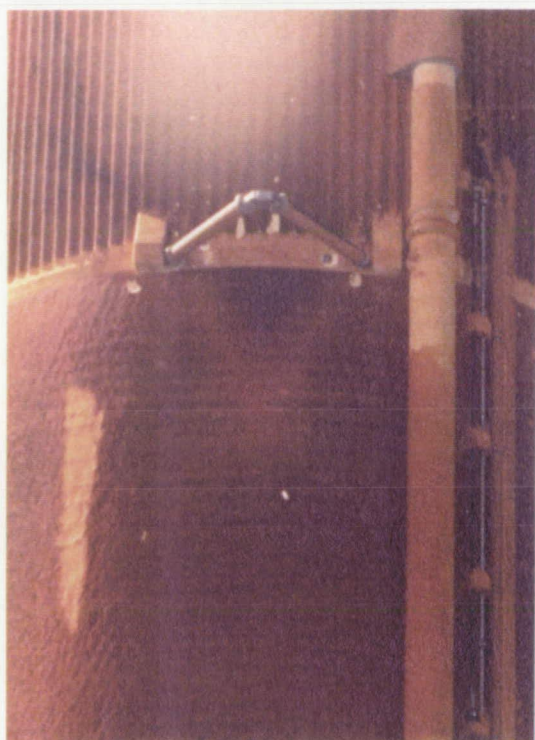
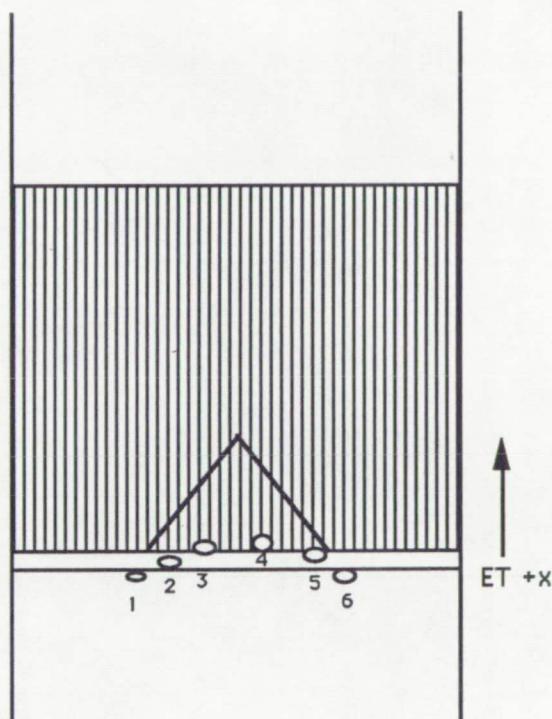
**Figure 2.4.2.3 (A)** Divots Seen on ET TPS  
(Frame STS-54-51-042)

Divots have been seen near the forward ET/Orbiter attach bipod, along the intertank close-out and on the intertank TPS on previous mission films. Since reflight, divots in these same regions were reported on STS-28R, STS-29R, STS-32R, STS-41R, STS-35, STS-37, STS-40, STS-42, STS-45 and STS-47. (The divot on STS-47 was declared an inflight anomaly.) Similar divots were also seen on films from several missions prior to reflight including STS-51R, STS-51F, STS-61A and STS-61C.
